# 2017 - surface porosity

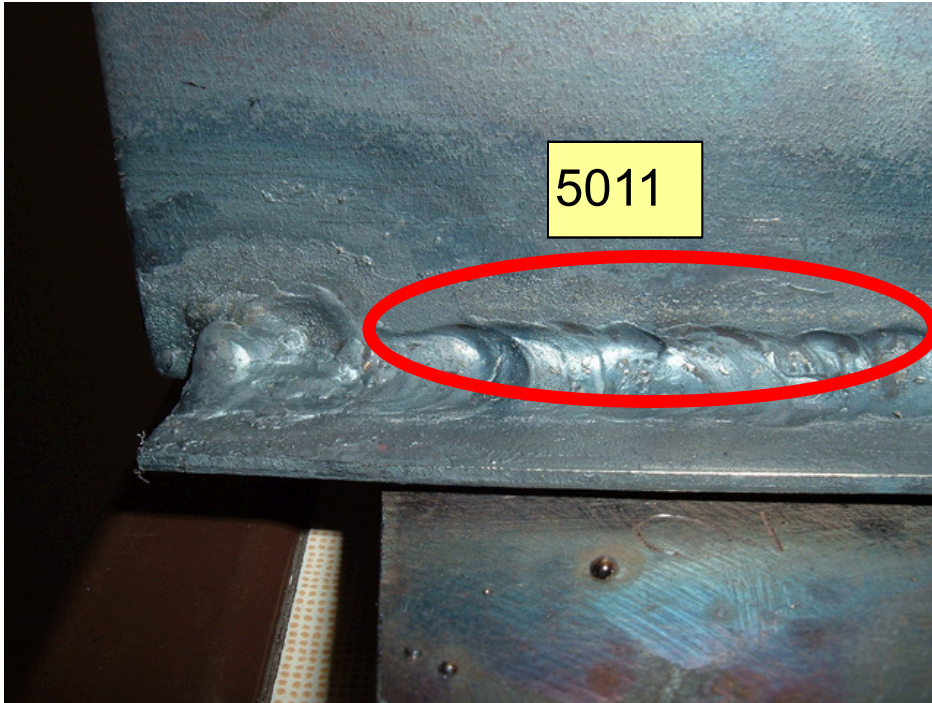
# 5011 - unwavering enthusiasm

Causes of occurrence:  
Unsuitable parameters  
Elevated forward velocity  
Irregular torch movement

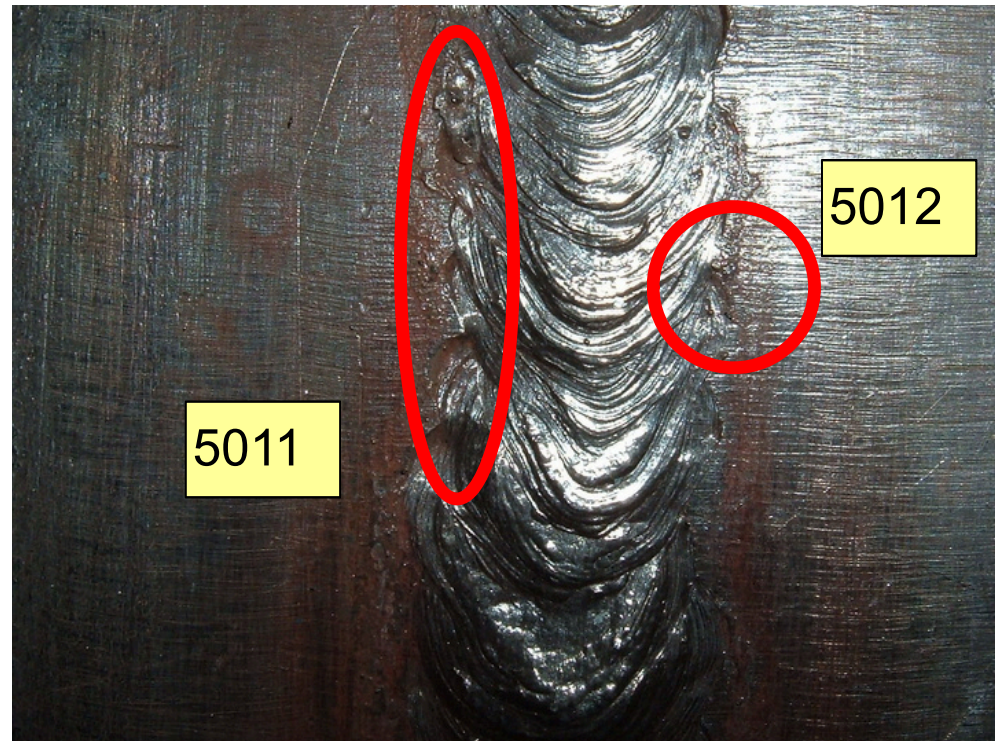
## 5012 - disjointed enthusiasm

Causes of occurrence:

- Unsuitable parameters
- Incorrect torch angle

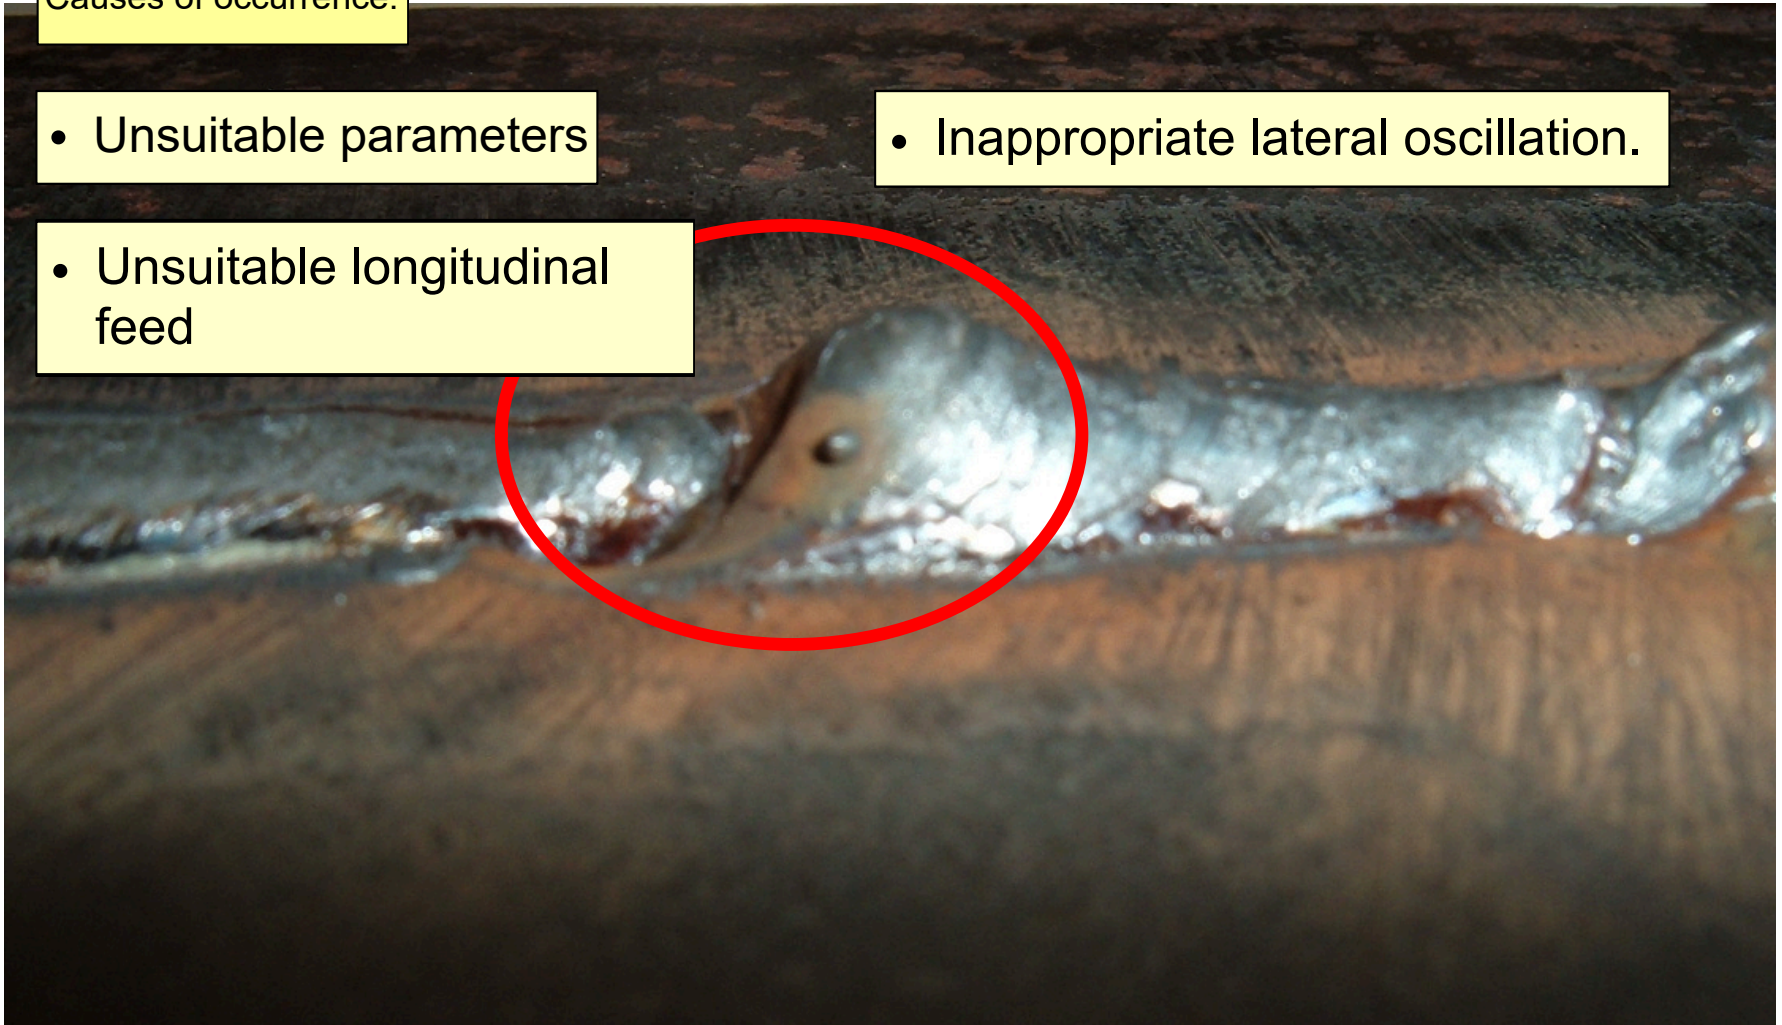
## 502 - excessive butt weld height

Causes of occurrence:

- Unsuitable parameters
- Unsuitable longitudinal feed
- Inappropriate lateral oscillation.

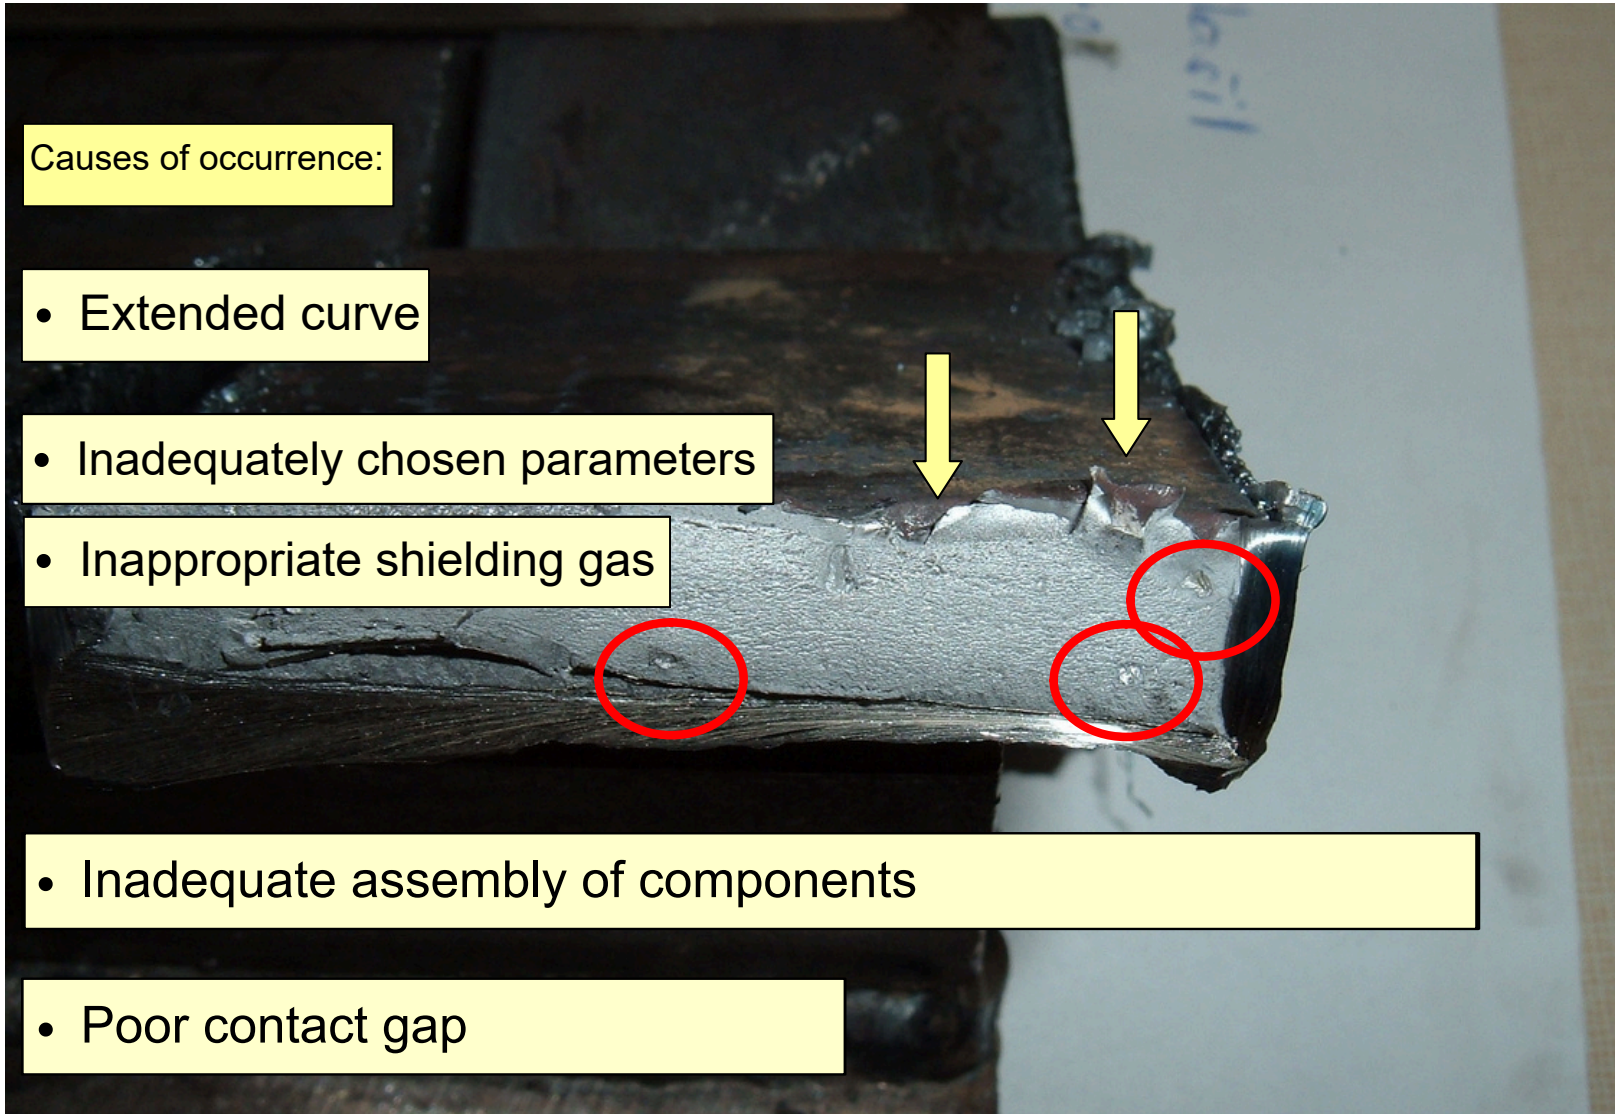
# 401 - cold junction 2017 - pores

Causes of occurrence:

- Extended curve
- Inadequately chosen parameters
- Inappropriate shielding gas
- Inadequate assembly of components
- Poor contact gap
